*Chapter 5***5.8.2 Walls**

6.4.3 Damage Analysis

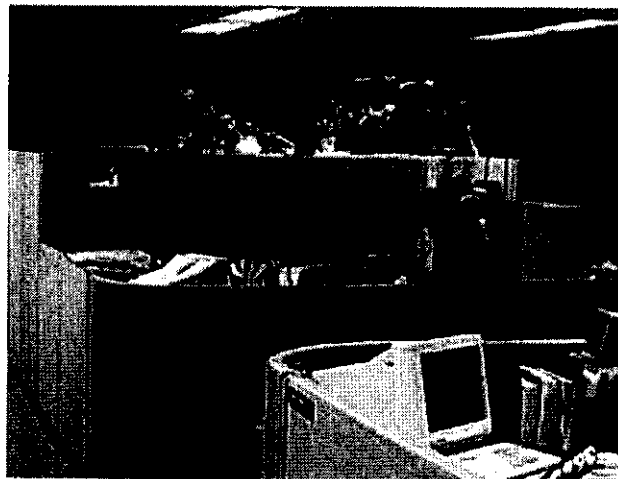
Figure 5-8. A WTC workstation.

The workstations were typically 8 ft square, bounded on all four sides by privacy panels, with an entrance opening in one side only. Within the area defined by the panels was a

self-contained workspace: desktop (almost always a wood product, generally with a laminated finish), file storage, bookshelves, carpeting, chair, etc. Presumably there were a variety of amounts and locations of paper, both exposed on the work surfaces and contained within the file cabinets and bookshelves. The cubicles were grouped in clusters or rows, with up to 215 units on a given floor.

The decorating styles of the tower tenants ranged from simple, modular trading floors to customized office spaces. The most common layout of the focus floors was a continuous open space populated by a large array of workstations or cubicles (Figure 1-11). The number of different types of workstations in the two towers was probably large. However, discussions with office furniture distributors and visits to showrooms indicated that, while there was a broad range of prices and appearances, the cubicles were fundamentally similar to that shown in Figure 5-8.

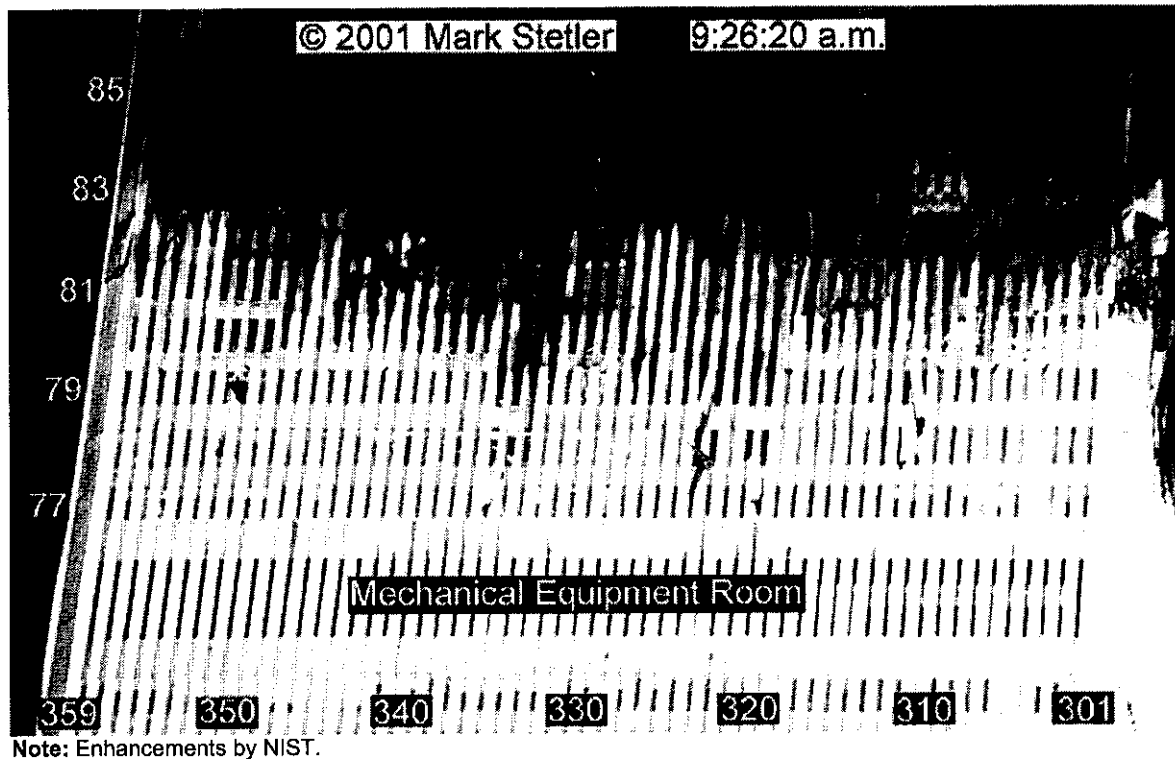
Figure 6-1. 9:26:20 a.m. showing the east face of WTC 2.

As an example of information that was extracted, Figure 6-1 shows an enhanced image of the east face of WTC 2. Figure 6-2 expands a section of interest. The amount of detail available is evident. For instance, large piles of debris are present on the north side of the tower on the 80th and 81st floors, and locations where fires are visible or where missing windows are easily identified. Many details of each frame were important in tracking the evolution of the fires and the damage to the buildings.

- The locations of the broken windows, providing information on the source of air to feed the fires within.
- Observations of the spread of fires.
- Documentation of the location of exterior damage from the aircraft impact and subsequent structural changes in the buildings.

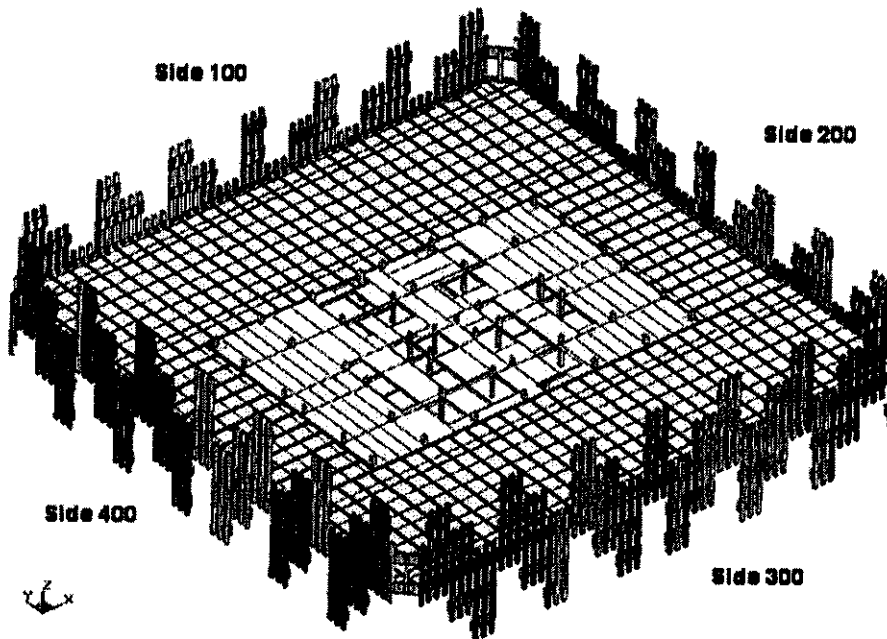
Figure 6-6. Structural model of the 96th floor of WTC 1.

- Core columns and spliced column connections;
- Floor slabs and beams within the core;
- Exterior columns and spandrels, including the bolted connections between the exterior panels in the refined mesh areas; and
- Tenant space floors, composed of the combined floor slab, metal decking, and steel trusses.

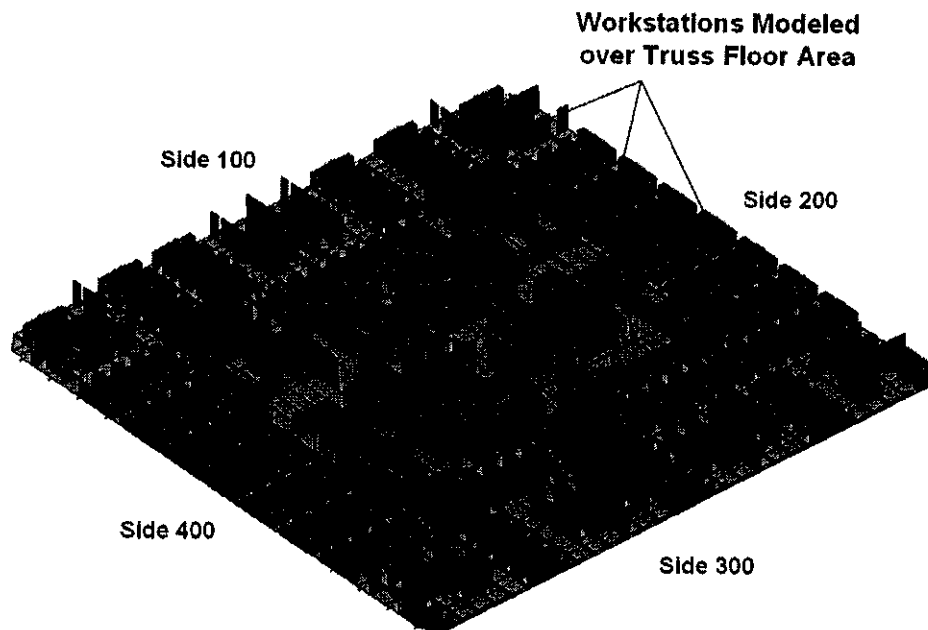
Figure 6-7. Model of the 96th floor of WTC 1, including interior contents and partitions.

They also included representations of the interior partitions and workstations. The live load mass was distributed between the partitions and cubicle workstations.

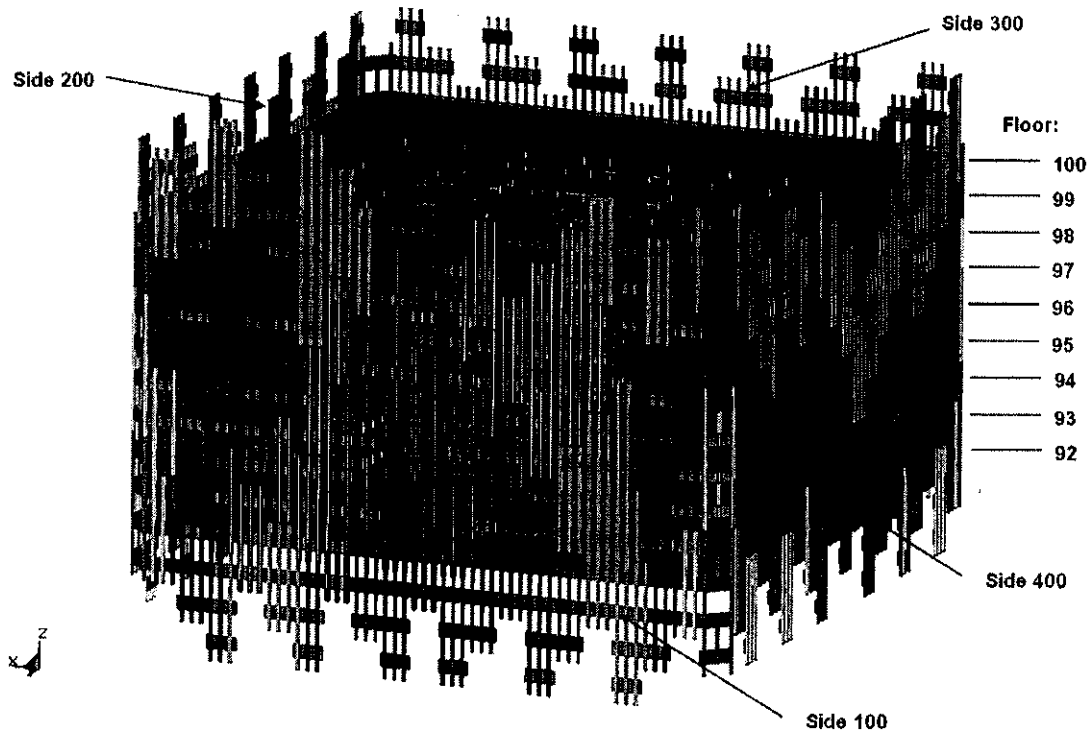
Figure 6-8. Multi-floor global model of WTC 1, viewed from the north.

Within these models, it was critical that the structural and furnishing materials behaved correctly when impacted by the aircraft or debris. For each grade of steel, the stress-strain behavior and the yield strength were represented using data from tests conducted at NIST. The weakening and failure of the concrete floor slabs were simulated using material models embedded in LS-DYNA. The primary influence of the nonstructural components on the impact behavior was their inertial contribution. Values for the resistance to rupture of gypsum panels and the fracture of the wood products in the workstations were obtained from published studies.

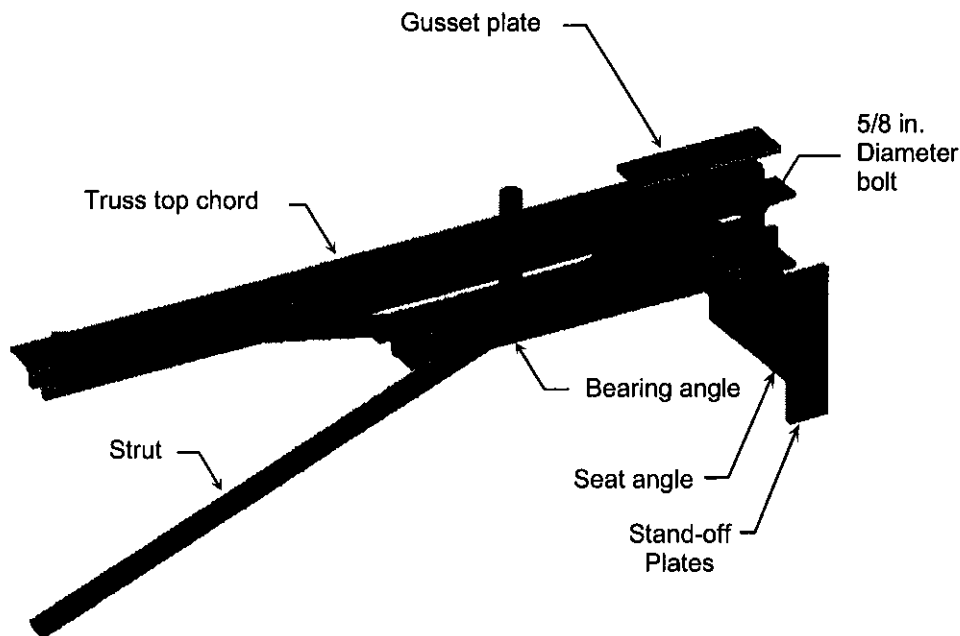
Figure 6-10. Finite element model of an exterior truss seat.

- **Truss seats.** Figure 6-10 shows how an exterior seat connection was represented in the finite element structural model. The component analysis determined that failure could occur at the bolted connection between the bearing angle and the seat angle, and the truss could slip off the seat. Truss seat connection failure from vertical loads was found to be unlikely, since the needed increase in vertical load was unreasonable for temperatures near 600 °C to 700 °C.
- **Knuckles.** The “knuckle” was formed by the extension of the truss diagonals into the concrete slab and provided for composite action of the steel truss and concrete slab. A model was developed to predict the knuckle performance when the truss and concrete slab acted compositely.

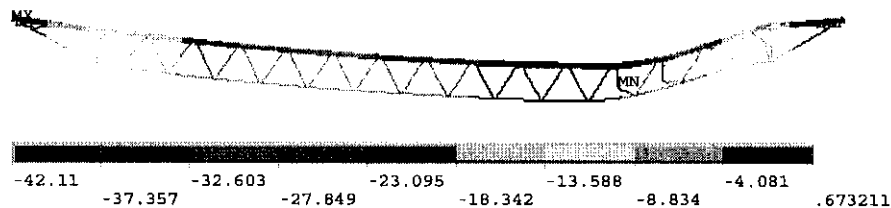
Figure 6-11. Vertical displacement at 700 °C.

- Single composite truss and concrete slab section. A floor section was modeled to investigate failure modes and sequences of failures under combined gravity and thermal loads. The floor section was heated to 700 °C (with a linear thermal gradient through the slab thickness from 700 °C to 300 °C at the top surface of the slab) over a period of 30 min. Initially the thermal expansion of the floor pushed the columns outward, but with increased temperatures, the floor sagged and the columns were pulled inward. Knuckle failure was found to occur mainly at the ends of the trusses and had little effect on the deflection of the floor system. Figure 6-11 shows that the diagonals at the core (right) end of the truss buckled and caused an increase in the floor system deflection, ultimately reaching approximately 42 in. Two possible failure modes were identified for the floor-truss section: sagging of the floor and loss of truss seat support.

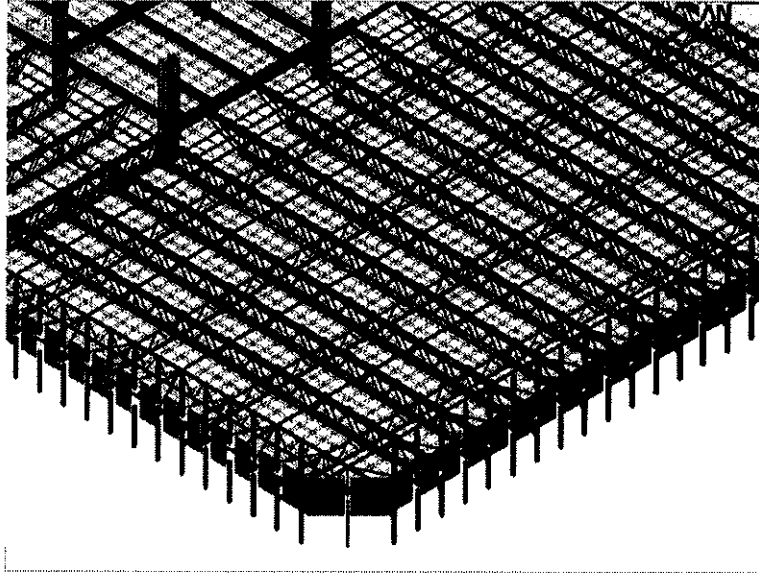
Figure 6–12. ANSYS model of 96th floor of WTC 1.

A finite element model of the full 96th floor of WTC 1 was translated from the SAP2000 reference models into ANSYS 8.1 for detailed structural evaluation (Figure 6–12)¹⁴. The two models generated comparable predictions of the behavior under dead or gravity loads.

The model was used to evaluate structural response under dead and live loads and elevated temperatures, identify failure modes and associated temperatures and times to failure, and identify reductions in modeling complexity for global models and analyses. The structural response included thermal expansion of steel and concrete members, temperature-dependent properties of steel and concrete that affected material stiffness and strength, and bowing or buckling of structural members. The deformation and failure modes identified were floor sagging between truss supports, floor sagging resulting from failure of a seat at either end of the truss, and failure of the floor subsystem truss supports.

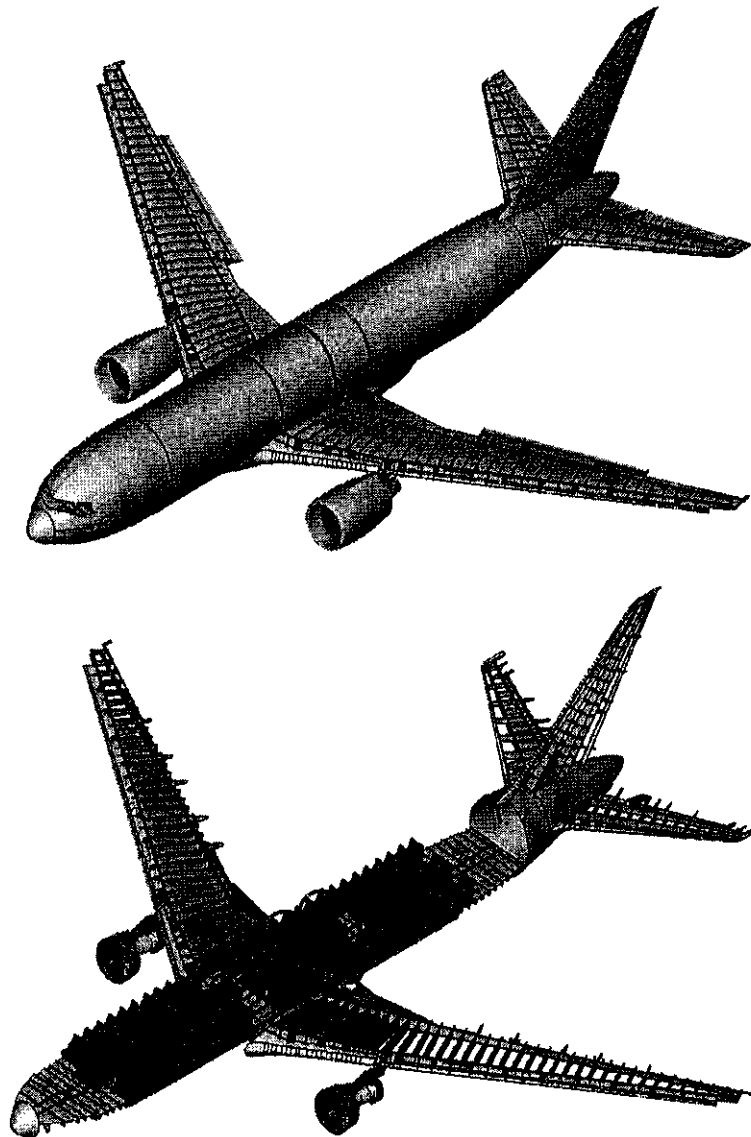
Figure 6-13. Finite element model of the Boeing 767-200ER.

Due to their similarity, the two Boeing 767-200ER aircraft were represented by a single, finite element model, two views of which are shown in Figure 6-13. The model consisted of about 800,000 elements. The typical element dimensions were between 1 in. and 2 in. for small components, such as spar or rib flanges, and 3 in. to 4 in. for large parts such as the wing or fuselage skin. Structural data on which to base the model were collected from the open literature, electronic surface models and CAD drawings, an inspection of a 767-300ER, Pratt and Whitney Engine Reference Manuals, American Airlines and United Airlines, and the Boeing Company website.

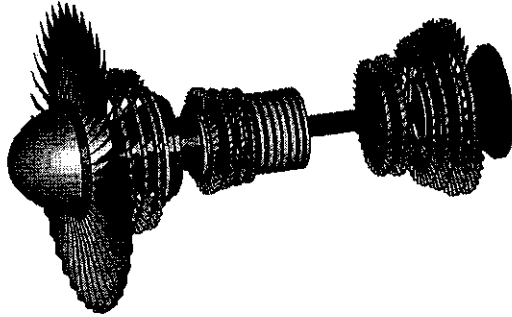
Figure 6-14. Pratt & Whitney PW4000 turbofan engine model.

More detailed models of subsections of the aircraft were constructed for the component level analyses described below. Special emphasis was placed on modeling the aircraft engines, due to their potential to produce significant damage to the tower components. The element dimensions were generally between 1 in. and 2 in., although even smaller dimensions were required to capture some details of the engine geometry. The various components of the resulting engine model are shown in Figure 6-14. Fuel was distributed in the wing as shown in Figure 6-15 based on a detailed analysis of the fuel distribution at the time of impact.

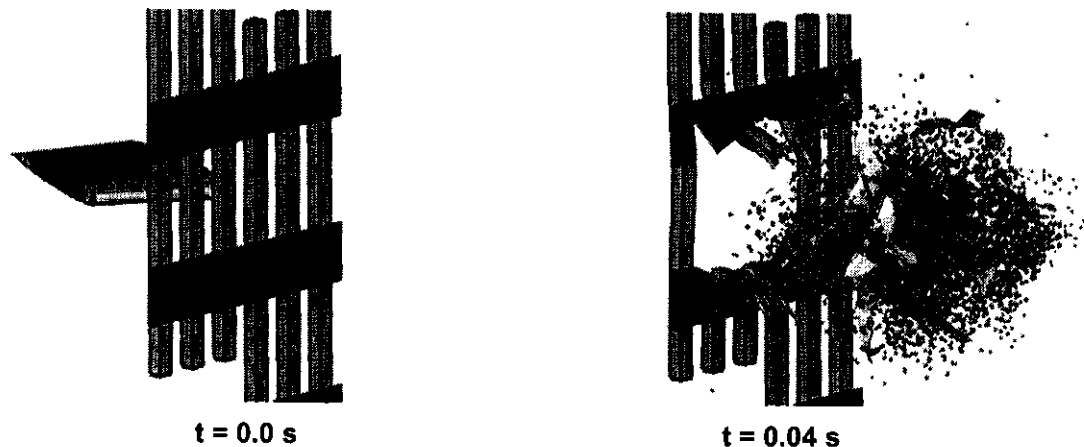
Figure 6–16. Calculated impact on an exterior wall by a fuel-laden wing section.

Figure 6–16 shows two frames from the last of these analyses, with the wing segment entering from the left, being fragmented as it penetrates the exterior columns, and spraying jet fuel downstream.

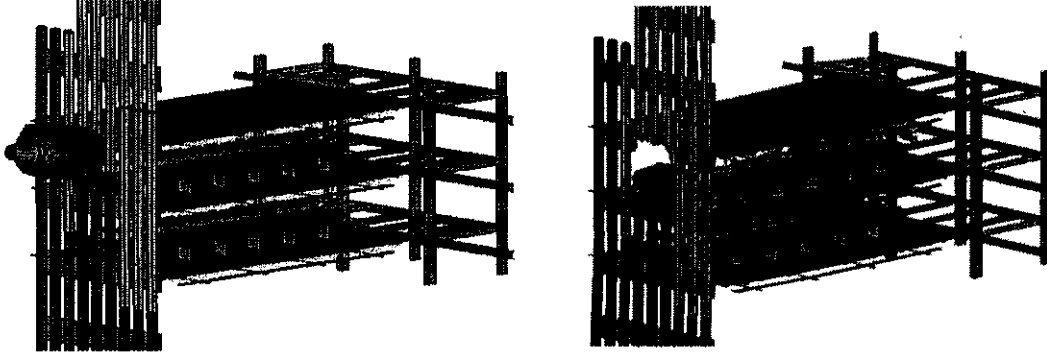
Figure 6-17. Response of a tower subassembly model to engine impact.

Next, a series of simulations were performed for intermediate-sized sections of a tower. These subassembly analyses investigated different modeling techniques and associated model sizes, run times, numerical stability, and impact response. Six simulations were performed of an aircraft engine impacting a subassembly that included structural components from the impact zone on the north face of WTC 1, exterior panels, truss floor structures, core framing, and interior contents (workstations). One response of the structure to the engine impact is shown in Figure 6-17.

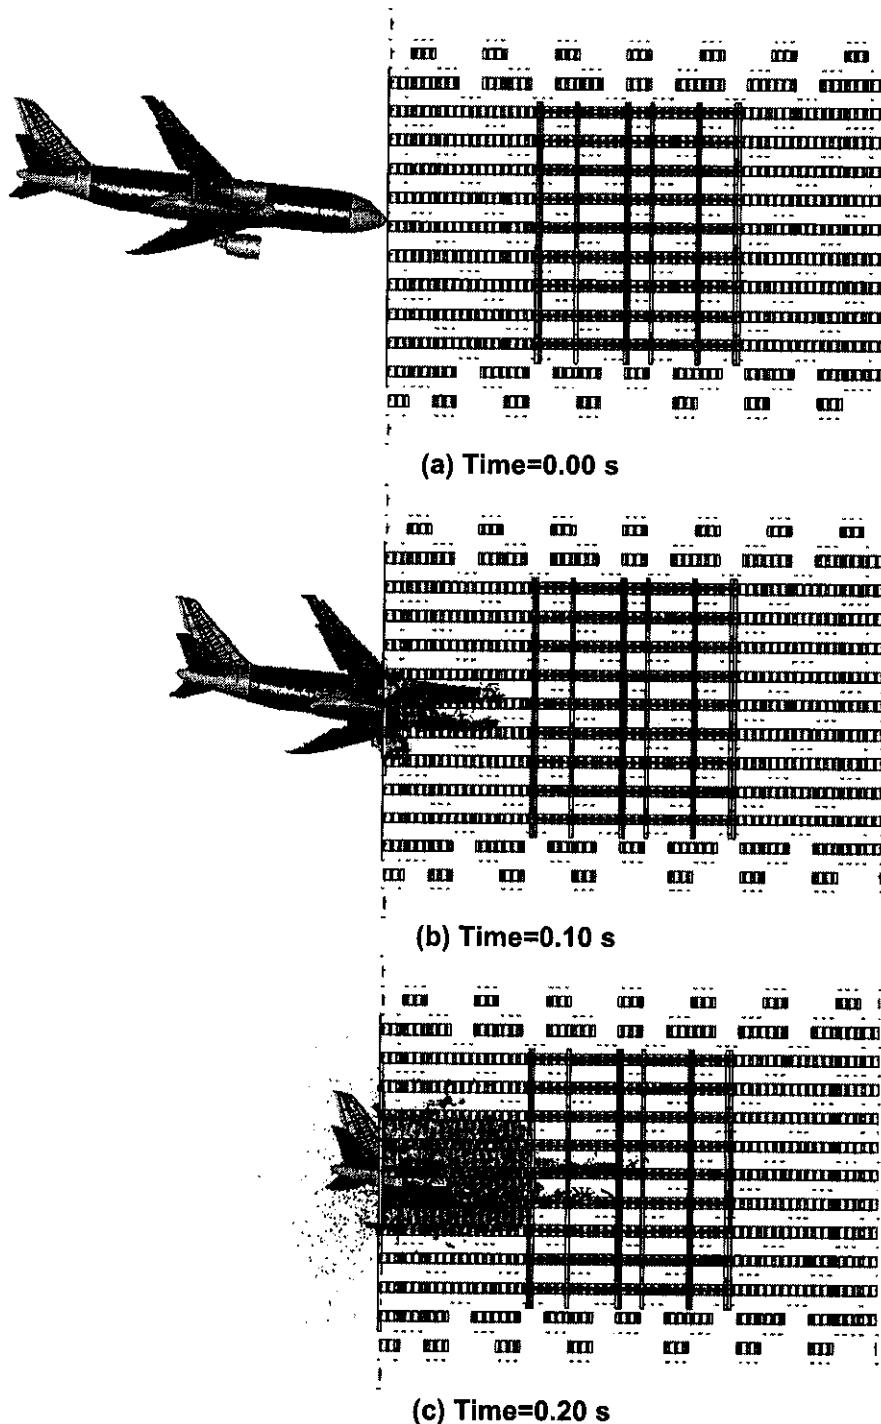
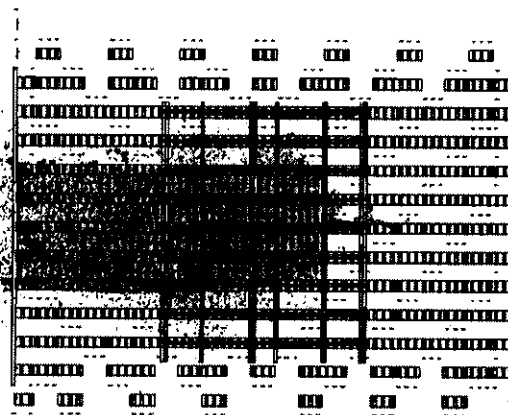
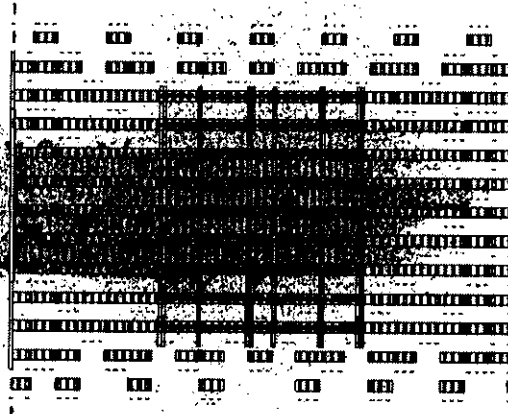
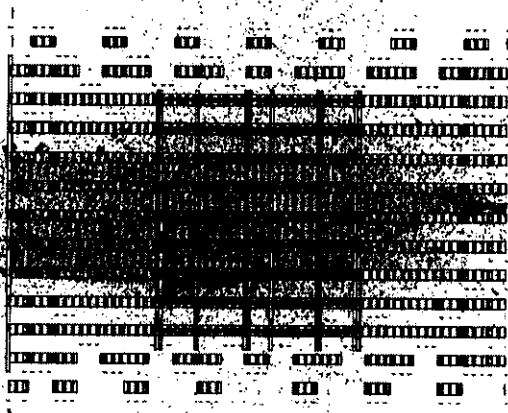
Figure 6–18. Side view of simulated aircraft impact into WTC 1, Case B.

These simulations each took about 2 weeks on a 12-node computer cluster. Figure 6–18 shows six frames from the animation of one such simulation.

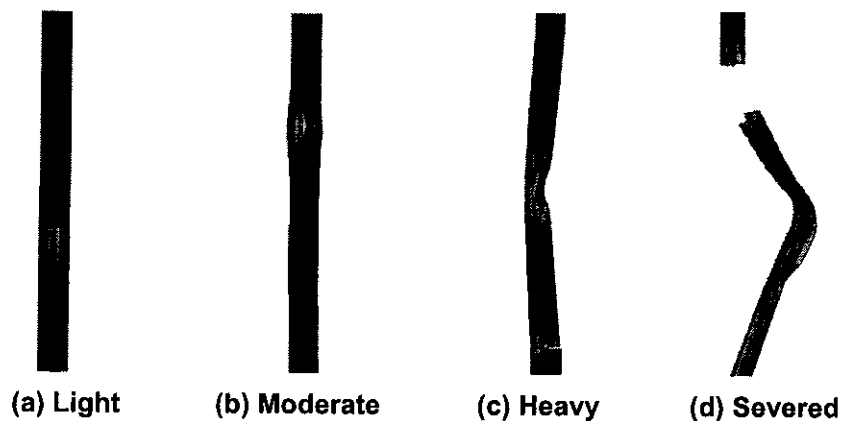
Figure 6–19. Column damage levels.

Each of the four global simulations generated information about the state of the structural components following the impact of the aircraft. The four degrees of column damage are defined as follows and shown graphically in Figure 6–19. The unstrained areas are blue and the highly strained areas are red.

- Lightly damaged column: column impacted, but without significant structural deformation;
- Moderately damaged column: visible local distortion, but no deformation of the column centerline;
- Heavily damaged column: Permanent deflection of the column centerline; and
- Failed column: Column severed.

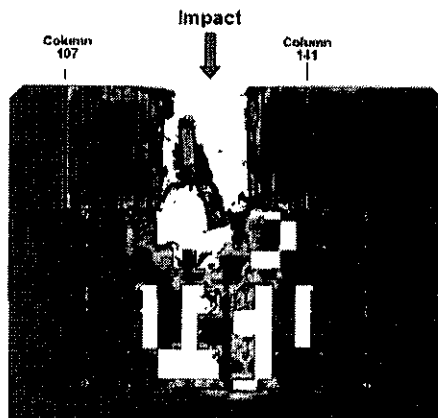
Figure 6–20. Case B damage to the slab of floor 96 of WTC 1.

Figure 6–20 shows the calculated damage to a floor slab. Figure 6–21 shows the response of the furnishings and the jet fuel to the impact. Figures 6–22 through 6–25 show the combined damage for all floors for the four global simulations. The latter proved useful in visualizing the extent of aircraft impact in one graphic image.

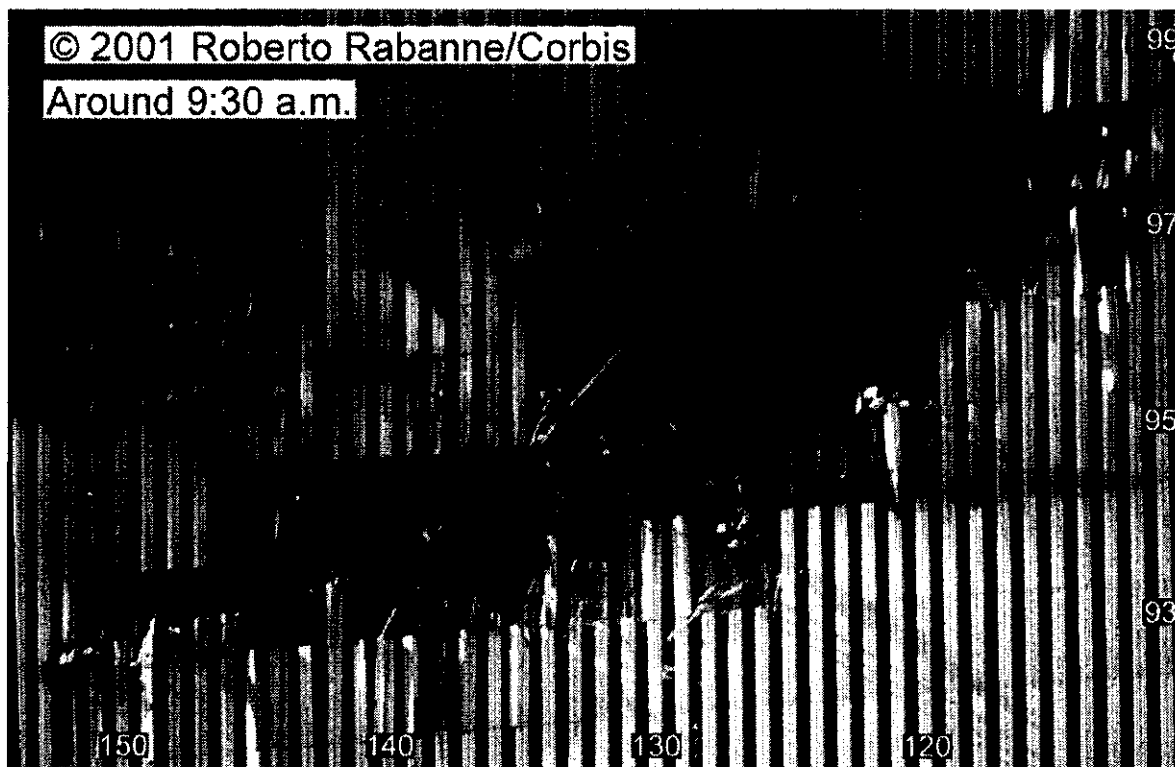
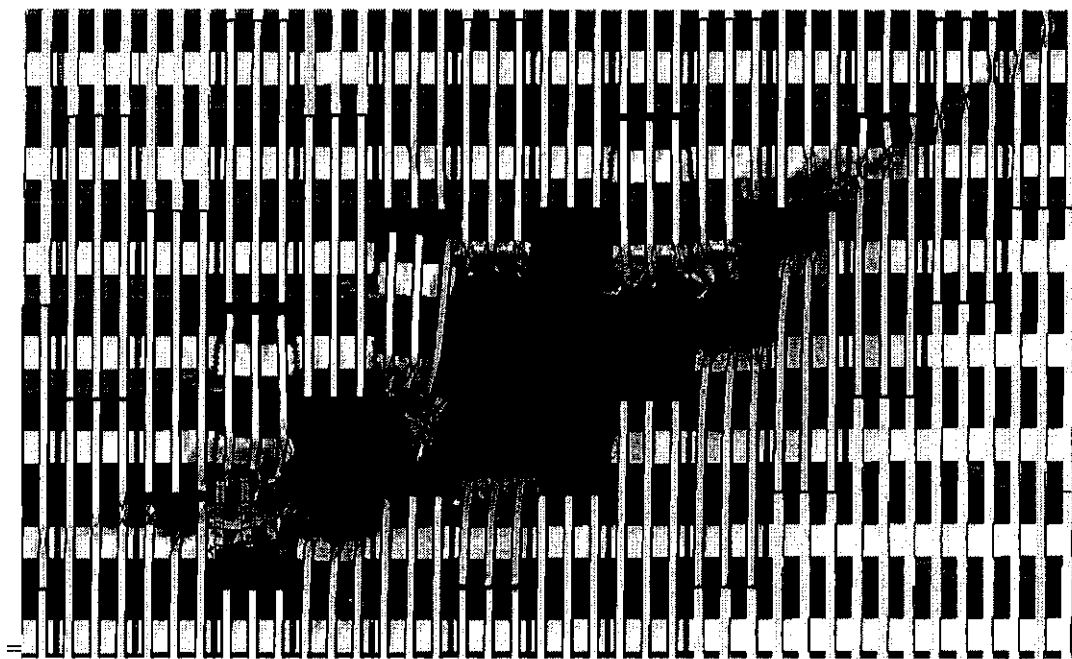
Figure 6-26. Observed and Case A calculated damage to the north face of WTC 1.

Assessment of the aircraft impact simulations of exterior damage to the towers involved comparing the predicted perimeter wall damage near the impact zone with post-impact photographs of the walls. Figure 6-26 shows a photograph of the north face of WTC 1 after impact and the results of the Case A simulation. The calculated silhouettes capture both the position and shape of the actual damage.

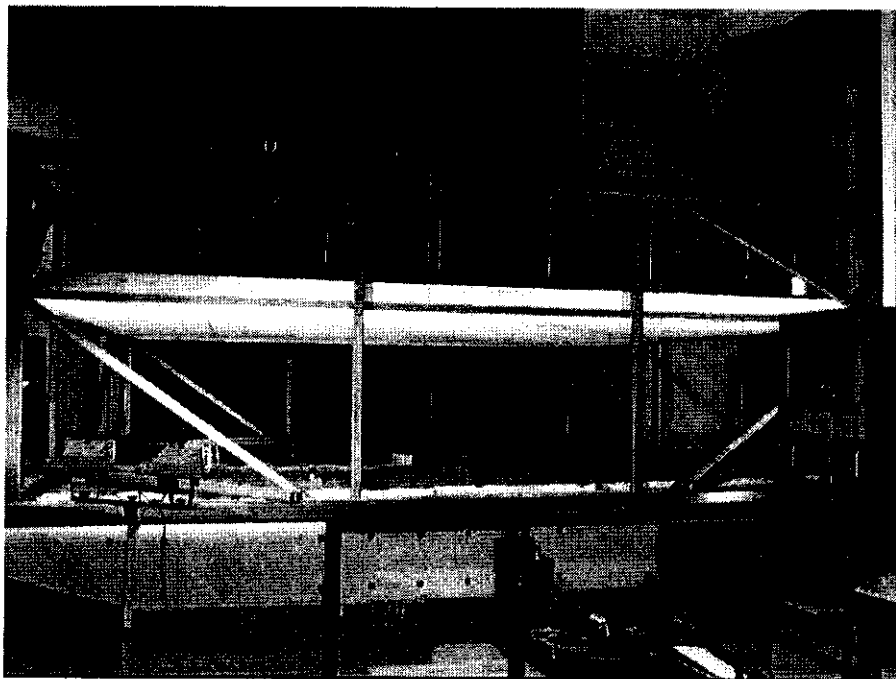
Figure 6–29. Ceiling tile system mounted on the shaking table.

The aircraft impact modeling did not include the ceiling tile systems. To estimate whether the tiles would survive the aircraft impact, the University at Buffalo, under contract to NIST, conducted tests of WTC-like ceiling tile systems using their shake table (Figure 6–29) and impulses related to those induced by the aircraft impact on the towers. The data indicated that accelerations of approximately 5g would most likely result in substantial displacement of ceiling tiles. Given the estimated impact accelerations of approximately 100g, NIST assumed that the ceiling tiles in the impact and fire zones were fully dislodged. This was consistent with the multiple reports of severely damaged ceilings (Chapter 7).

An intact ceiling tile system could have provided the floor trusses with approximately 10 min to 15 min of thermal protection from ceiling air temperatures near 1,000 °C. These temperatures would quickly heat steel without thermal insulation to temperatures for reduction of the strength of structural steels.

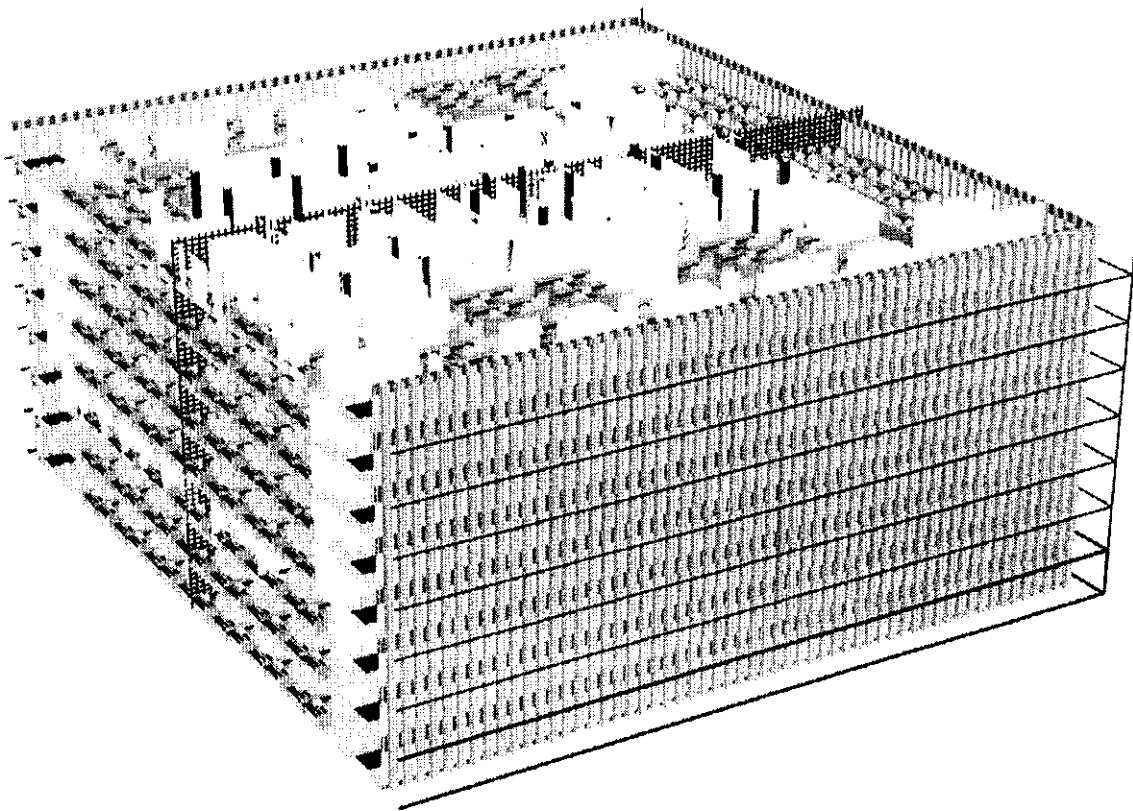
Figure 6–30. Eight floor model of WTC 1 prior to aircraft impact.

FDS represented the spaces in which the fires and their effluent were to be modeled as a grid of rectangular cells. These grids included the walls, floors, ceilings, and any other obstructions to the movement of air and fire. In the final simulations, the grid size was 0.5 m x 0.5 m x 0.4 m high (1.6 ft x 1.6 ft x 1.3 ft.). Each floor contained about 125,000 grid cells, and the nature of each cell was updated every 10 ms (100 times every second). The computations were performed using parallel processing, in which the fires on each floor were simulated on a different computer. At the end of each 10 ms update, the processors exchanged information and proceeded to the computations for the next time interval. Each simulation of 105 min of fires for WTC 1 took about a week on eight Xeon computers with a combined 16 GB of memory. The simulations for WTC 2, with fewer floors and 60 min of real time fires, took about half the time.

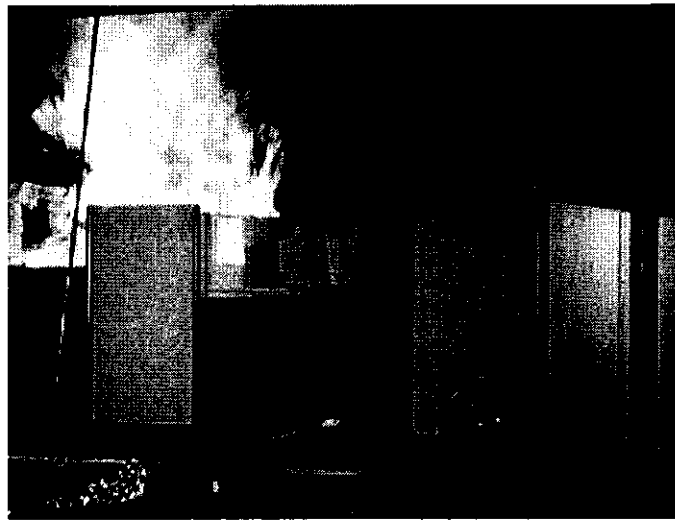
Figure 6–31. Fire test of a single workstation.

The floors of the tower on which the dominant burning occurred were characterized by large clusters of office workstations (Figure 1–11). NIST determined their combustion behavior from a series of single-workstation fire tests (Figure 6–31). In these highly instrumented tests, the effects of workstation type, the presence of jet fuel, and the presence of fallen inert material (such as pieces of ceiling tiles or gypsum board walls) on the burning surfaces were all assessed. While FDS properly captured the gross behavior of these fires, the state of modeling the combustion of real furnishings was still primitive. Thus, the results of this test series were used to refine the combustion module in FDS.

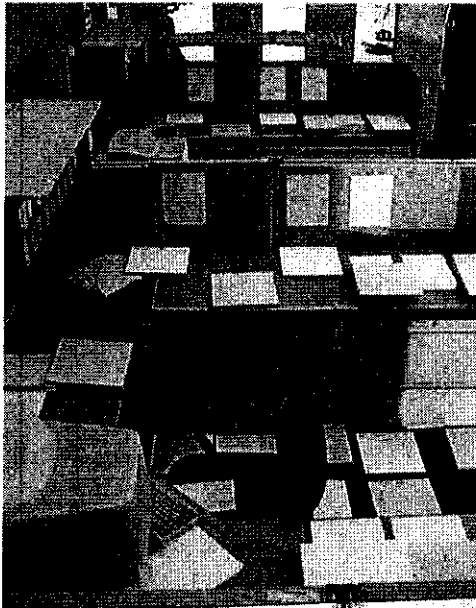
Figure 6–32. Interior view of a three-workstation fire test.

The second series was a preamble to the modeling of the actual WTC fires. Arrays of three WTC workstations were burned in a 35.5 ft by 23 ft by 11 ft high compartment (Figure 6–32). The tests examined the effects of the type of workstation, the presence of jet fuel, and the presence of fallen inert material on the burning surfaces. In one of the tests, the workstations were rubblized (Figure 6–33). Figure 6–34 depicts the intensity of the test fires. Figure 6–35 shows the measured and predicted heat release rate data from one of the tests in which there was no jet fuel nor inert material present.
